**Flood Control Project Maintenance
Levee Inspections**

Fall 2011 Levee Maintenance Deficiency Summary Report

Sacramento River Basin

Reclamation District No. 0010 Honcut

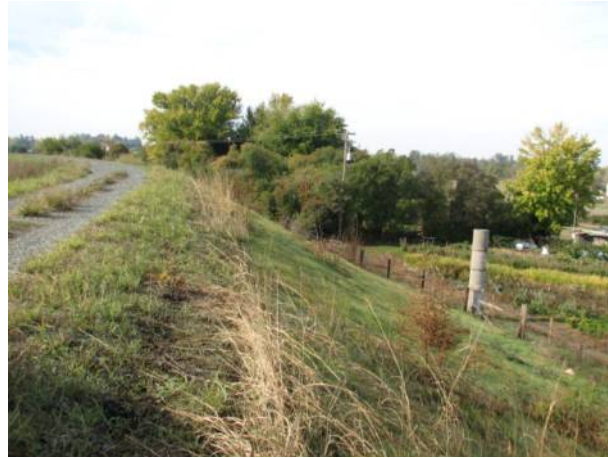
Levee Mile Report Line	1
Start Levee Mile	0.01
End Levee Mile	0.57
Location	Land Side
Category	Earthen Levee
Item	Vegetation

This photo shows the landside vegetation at levee mile 1.35.

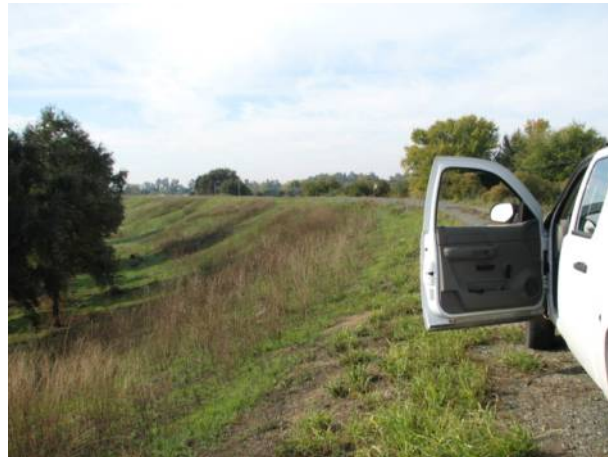
Levee Mile Report Line	2
Start Levee Mile	0.01
End Levee Mile	0.57
Location	Water Side
Category	Earthen Levee
Item	Vegetation

This photo shows the waterside vegetation at levee mile 1.35.

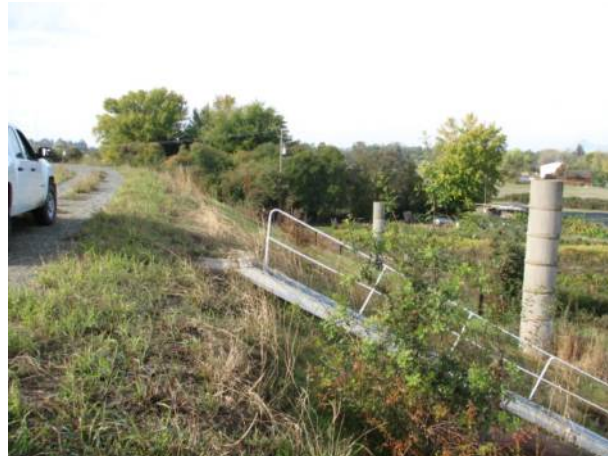
Levee Mile Report Line	7
Start Levee Mile	1.35
End Levee Mile	1.35
Location	Land Side
Category	Earthen Levee
Item	Trim / Thin Trees

This photo shows the trees on the slope near the stairs at levee mile 1.35.

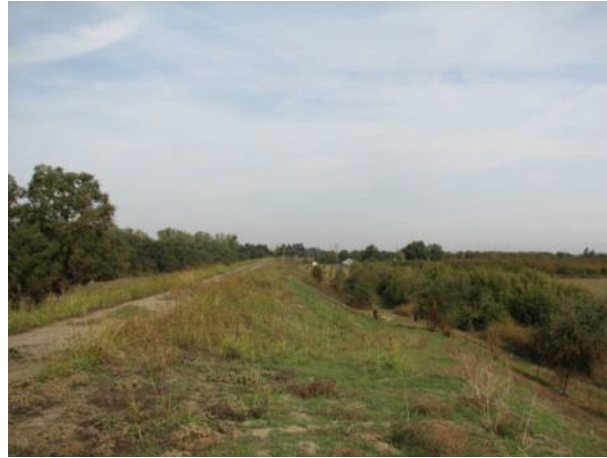
Levee Mile Report Line	1
Start Levee Mile	0.03
End Levee Mile	6.70
Location	Land Side
Category	Earthen Levee
Item	Vegetation

This photo shows the landside vegetation at levee mile 0.03.

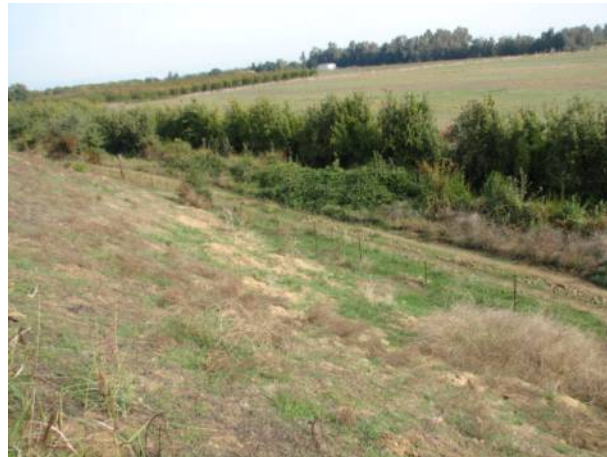
Levee Mile Report Line	2
Start Levee Mile	0.03
End Levee Mile	0.03
Location	Land Side
Category	Earthen Levee
Item	Animal Control

Rodent burrows at levee mile 0.03.

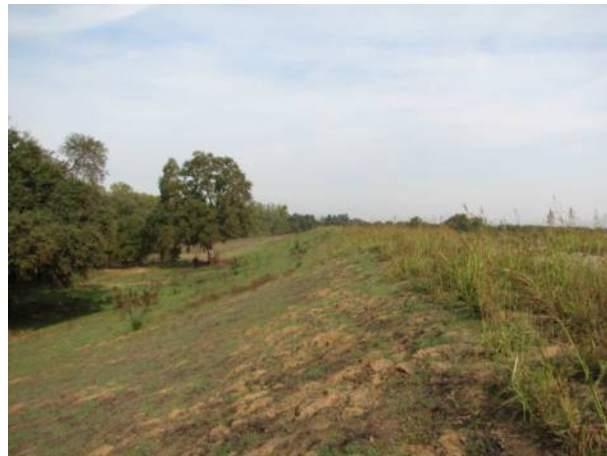
Levee Mile Report Line	3
Start Levee Mile	0.03
End Levee Mile	6.70
Location	Water Side
Category	Earthen Levee
Item	Vegetation

This photo shows the waterside vegetation at levee mile 0.03.

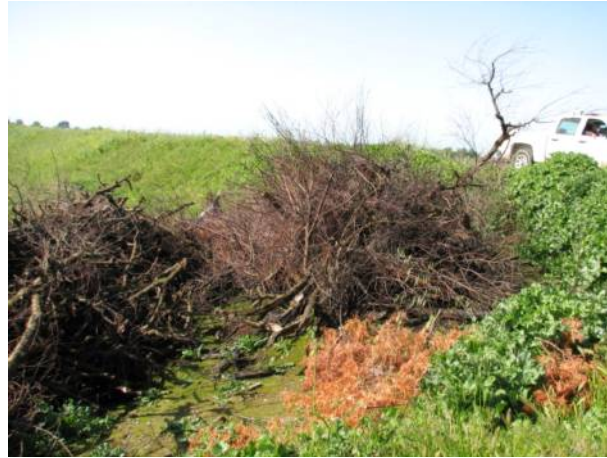
Levee Mile Report Line	19
Start Levee Mile	9.30
End Levee Mile	9.30
Location	Land Side
Category	Earthen Levee
Item	Encroachments
Land side levee mile 9.30.	
cathom_f_20110929_059.jpg

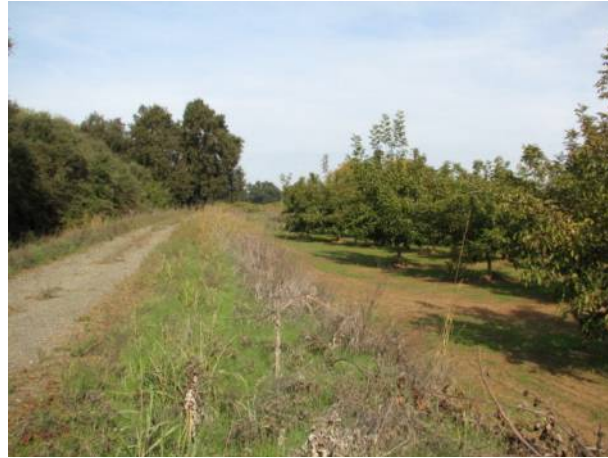
Levee Mile Report Line	1
Start Levee Mile	0.02
End Levee Mile	2.90
Location	Land Side
Category	Earthen Levee
Item	Vegetation

This photo shows the landside vegetation at levee mile 0.02.

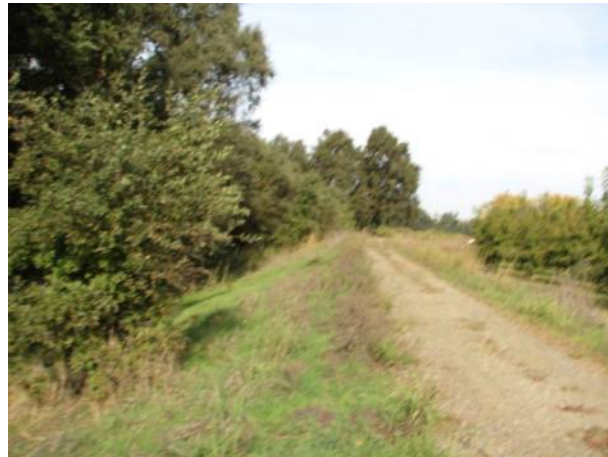
Levee Mile Report Line	2
Start Levee Mile	0.02
End Levee Mile	2.90
Location	Water Side
Category	Earthen Levee
Item	Vegetation

This photo shows the waterside vegetation at levee mile 0.02.
